Official Accident Report Index Page

GROUND SPOILER ACTIVATION IN FLIGHT/HARD
LANDING VALUJET AIRLINES FLIGHT 558
DOUGLAS DC-9-32, N922VV NASHVILLE,
TENNESSEE JANUARY 7, 1996

Weather conditions	Ice, snow
Total crew size	5
Cockpit crew size	2
Cabin crew size	3
Passengers	88
Report ID	NTSB/AAR-96-07
Pages	174
Day or night?	Day
Flight number	558
Flight origin	Atlanta, GA

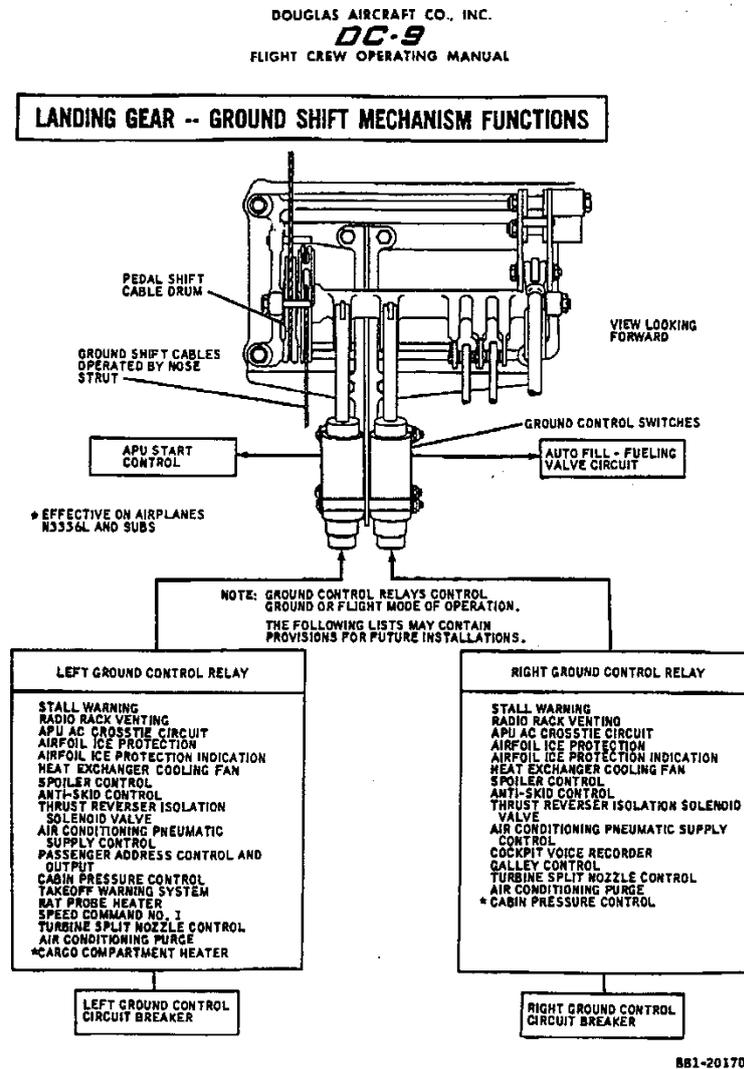
Figure 2--DC-9 Ground Shift Mechanism

The ground shift mechanism, which is actuated by nosegear shock strut extension/compression, controls whether certain aircraft systems operate in the ground or flight mode.²¹ When the nosegear shock strut is compressed by the weight of the aircraft, the ground shift mechanism causes those aircraft systems to be operated in the ground mode. When the nosegear shock strut is extended after takeoff, it triggers the ground shift mechanism, electronically shifting the aircraft systems to the flight mode.²² In addition, when the aircraft is in the flight mode, the ground shift mechanism mechanically centers the nose wheel, locks out the rudder pedal nose wheel steering function, and releases the gear lever anti-retraction mechanism.

According to Douglas representatives, when the nosegear shock strut is underserviced/underinflated, strut extension after liftoff may not be sufficient to activate the ground shift mechanism to shift the aircraft systems into the flight mode and release the gear lever anti-retraction mechanism. Douglas representatives indicated that this is a commonly reported occurrence during cold weather operations. They stated that Douglas had issued numerous service bulletins (SBs) and all operator letters (AOLs) describing the anomaly and recommending maintenance procedures to avoid underserviced/underinflated nosegear shock struts during cold weather operations.²³

It is likely that the nosegear shock strut did not extend far enough to actuate the ground shift mechanism because it was underserviced/underinflated for the cold/winter weather conditions. The en route portion of the flight proceeded uneventfully. When the airplane was about 100 feet above the ground during the approach to Nashville, the pilots reset the ground control relay circuit breakers, thereby unintentionally shifting the airplane systems from the flight mode to the ground mode. The ground spoilers subsequently extended in flight, and the airplane descended suddenly, impacting the ground in the runway approach light area.

Accordingly, the Safety Board believes that ValuJet should develop, immediately, a more extensive and accurate winter operations manual, with corresponding adjustments to maintenance procedures, to reflect the manufacturer's cold weather nosegear servicing procedures. Further, because no airline is exempt from encountering a range of weather extremes, the Safety Board believes that the FAA should require all airlines to review their operations and maintenance manuals and, if necessary, adjust or expand these manuals to reflect the manufacturer's recommended cold weather nosegear servicing procedures.

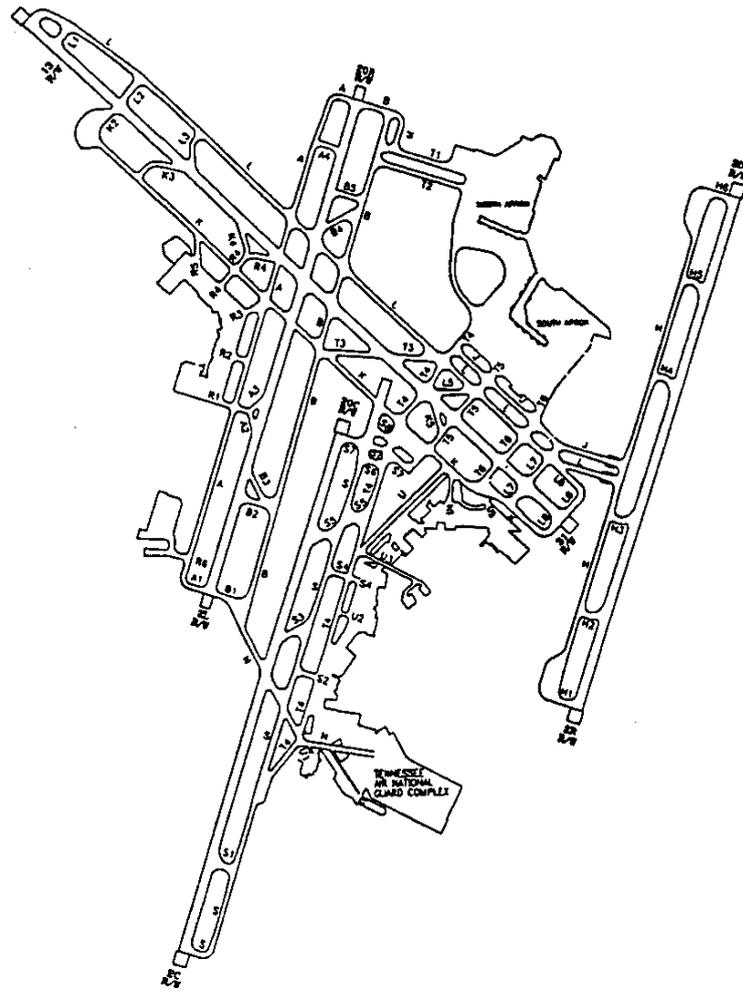
Figure 3—Nashville International Airport Diagram

Meanwhile, the pilots continued the approach to runway 31. The captain was flying the airplane, while the first officer advised the captain of their relative position to runway 31 and the length of the runway and briefed the approach. The pilots completed the "Before Landing" checklist, and the first officer extended flaps and slats for landing. The pilots decided not to arm the spoilers for landing because they planned to manually deploy the ground spoilers during the landing roll. As they approached the runway, the pilots observed emergency equipment with flashing lights moving into position near runways 2R and 31. ([See figure 3](#), "Airport Diagram.")

Debris from the nose landing gear and the runway approach lights was found at the approach end of runway 2R. The first indications of impact were ground scars in the runway approach light area, about 90 feet before the runway threshold lights. Two runway threshold lights and two runway approach lights were damaged.

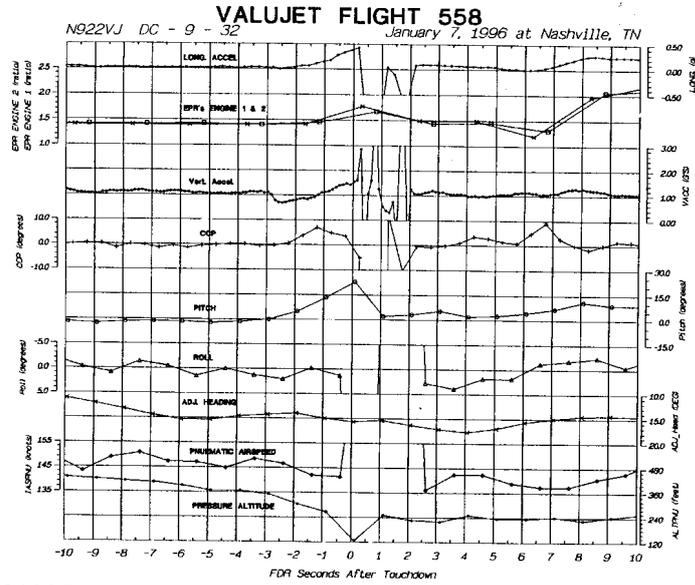
Initial Touchdown Plot
Revised: December 11, 1996

The cases of both recorders were intact and exhibited no evidence of damage or excessive wear. Aside from loss of FDR data coincident with the airplane's hard touchdown, good quality recordings were obtained from both recorders.[28](#)
